LEVEL 2 REPLACEMENT RESERVE REPORT FY 2025 ROCKLAND RUN

ROCKLAND RUN

BALTIMORE, MARYLAND
September 30, 2024

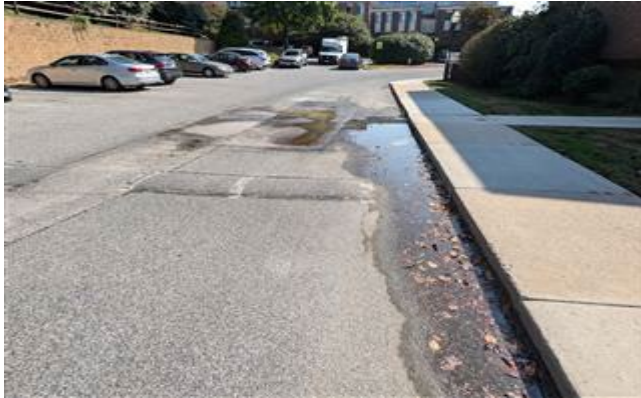
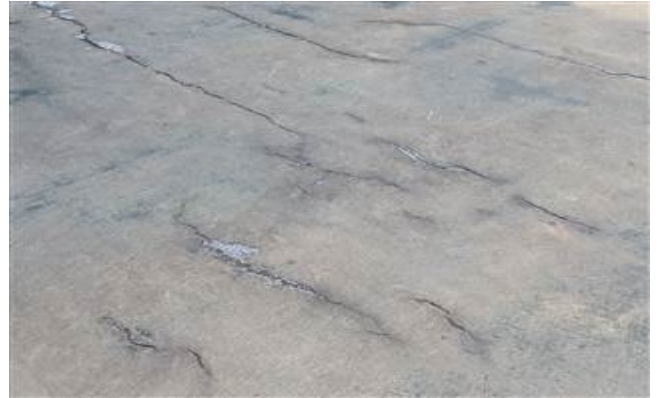
Resurfacing has been programmed to occur in three phases. Phase (1), Snow Meadow Lane. Phase (2), Suntop Court. Phase (2), Windblown and Longstream Courts.

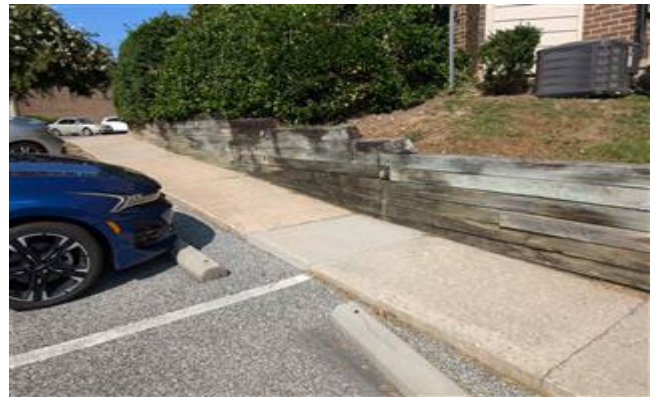
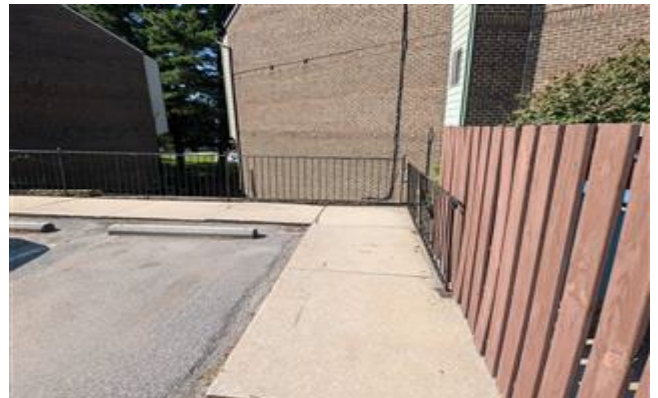
Because it is highly unlikely that all of the concrete components will fail and require replacement in the period of the study, we have programmed funds for the replacement of these inventories and spread the funds over an extended timeframe to reflect the incremental nature of this work.

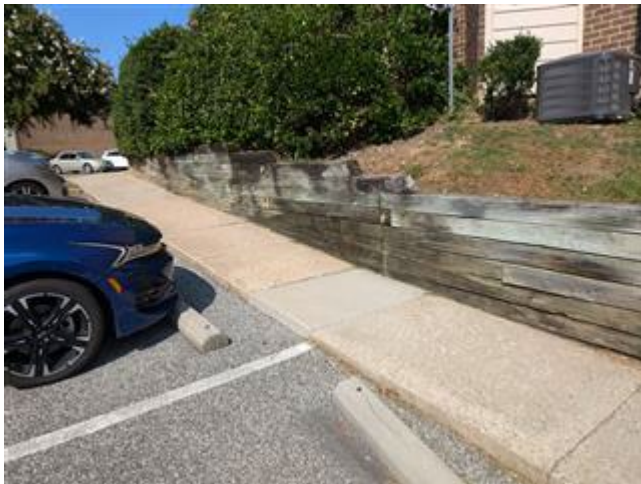
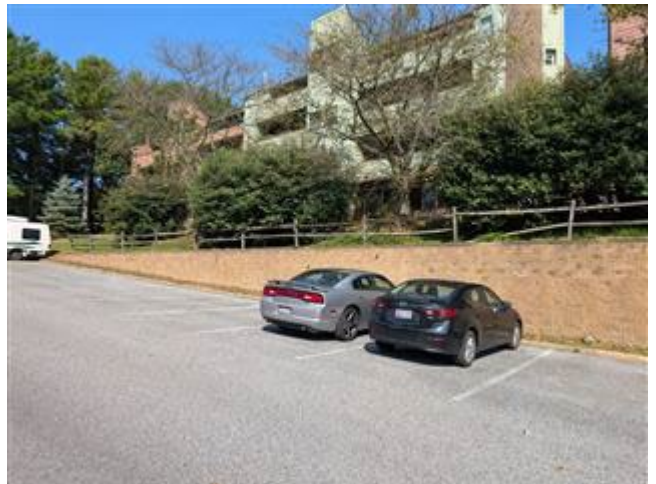
Retaining Walls. The Association maintains a large segmented block wall on the north side of Snow Meadow Lane and multiple pressure-treated lumber retaining walls throughout the community. The largest of the wood retaining walls is located on the south side of Snow Meadow Lane. The PTL retaining walls appear to be in fair overall condition.

The movement and displacement of retaining walls is a sign of general settlement or failure. This typically is in the form of leaning and bowing and can involve the entire wall or localized sections of the wall. Typically, these types of movements are gradual and may require the replacement of the wall. The movement of retaining walls located near other buildings or structures may negatively affect the stability of the adjacent structure. These conditions can become extremely costly if not properly identified, monitored, and addressed.

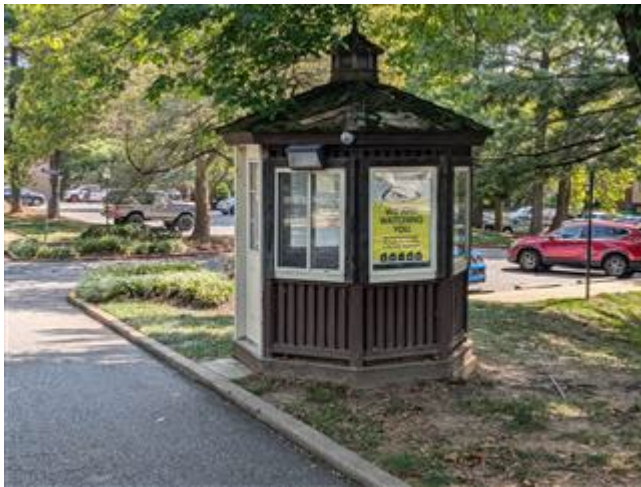
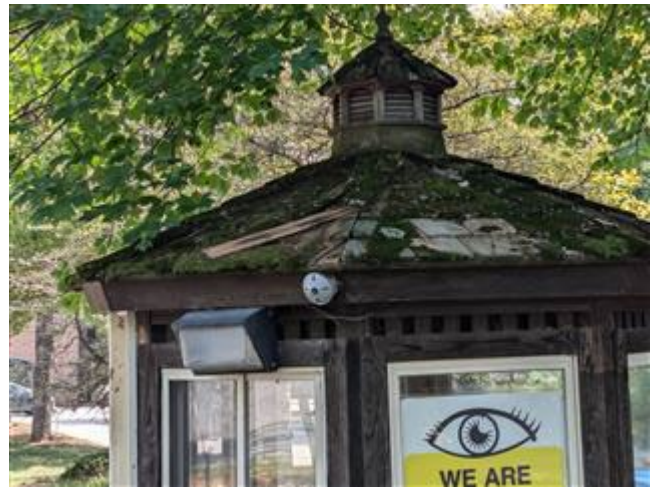
Entrance Booth. The Association maintains a small entrance booth at the entrance of the community on Snow Meadow Lane. The booth appears to be in good overall condition, with the exception of the shake cedar roof. Funding for a one-time roof replacement and the booth's future replacement has been programmed in the analysis. The booth may be considered aesthetically worth maintaining.

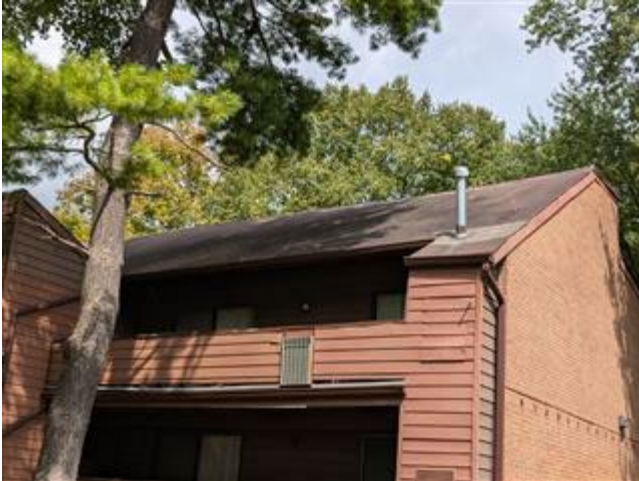
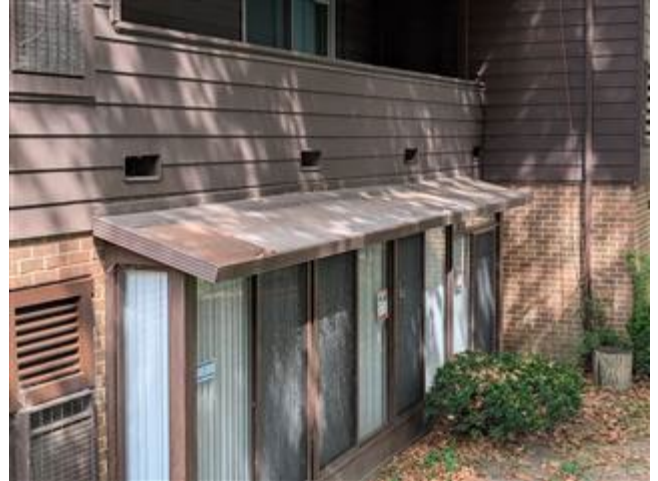
Building Roofing. The community's buildings' roofs are a combination of shingle and flat roofing systems. There have been reported issues of leaking. There is no record of any substantial roof replacements, currently, roofs are being replaced where there are incidences of leaking. Since the 2019 study, approximately 40% of the roof systems have been replaced. It is assumed the remaining roofs are in poor condition. It is suggested the Association contract with a qualified building envelope firm to develop a comprehensive roof replacement program. For funding purposes, the replacement of the remaining 60% of all roofs in three phases, in the next four years has been programmed in the analysis.

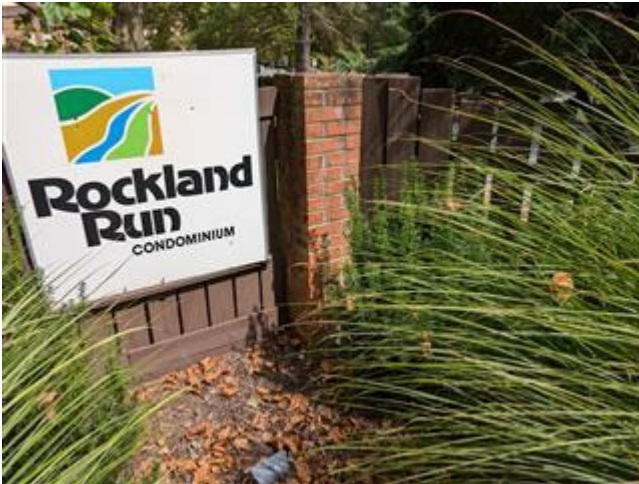
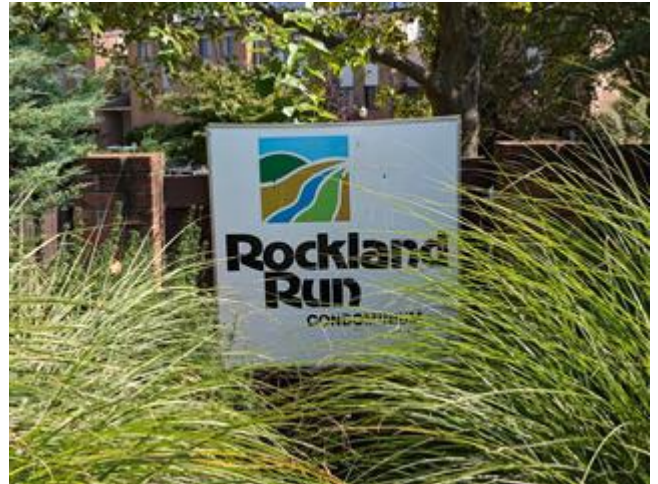
Entry Monument and Signage. The Association maintains a painted synthetic sign and supporting wood fencing at the entrance to the community on Snow Meadow Lane. The sign and fencing are in their latter stage of service life. The sign is illuminated by single ground spotlight

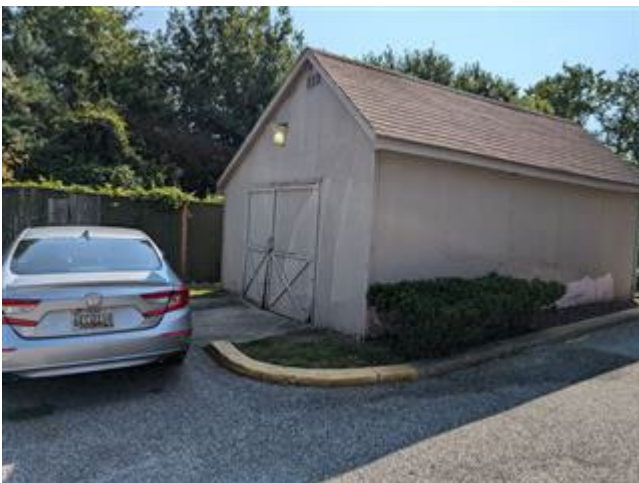
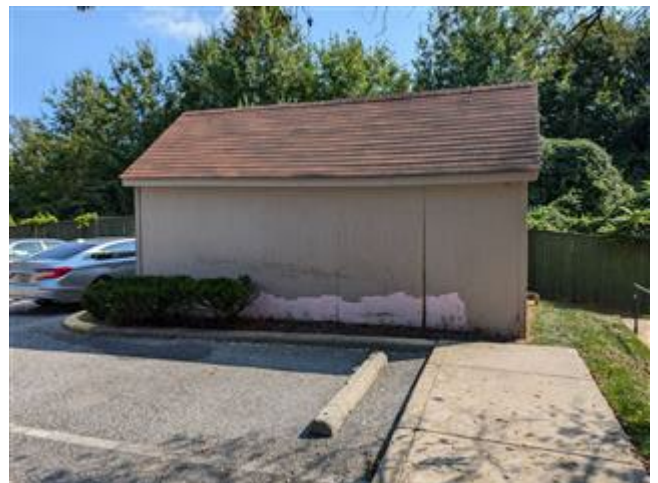
Sheds. The Association owns one wood frame shed that is used for storage purposes. The shed appears to be in fair condition. We have assumed that the components of the shed's exterior will be replaced as needed, and when a complete replacement is required, it will be replaced with one of a similar type and size.

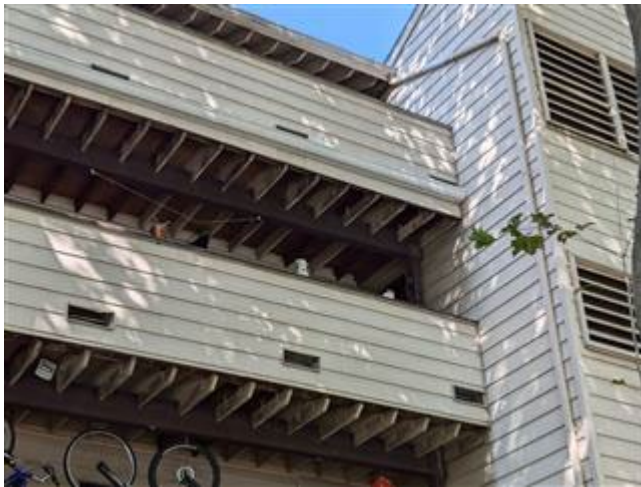
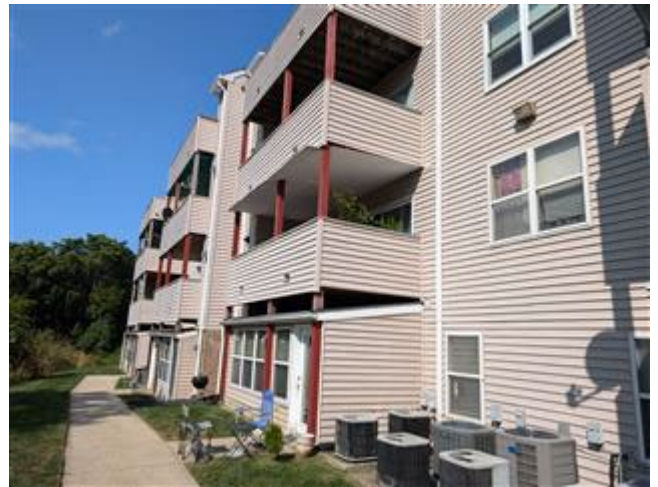
It is recommended that gutters and downspouts be installed on all buildings. It is also recommended that the discharge from the downspouts be extended at least ten feet away from the foundations.

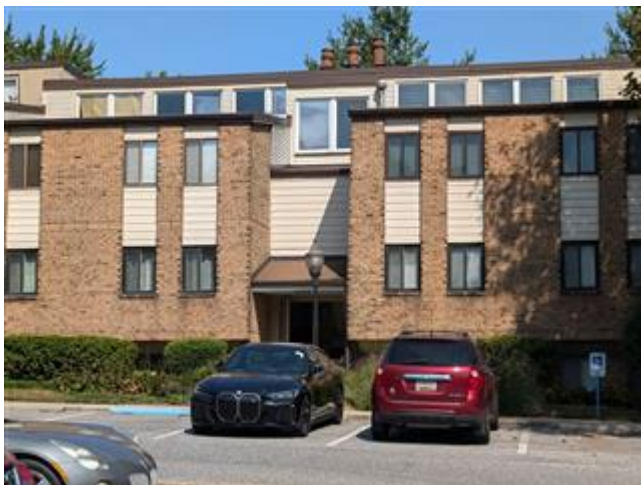
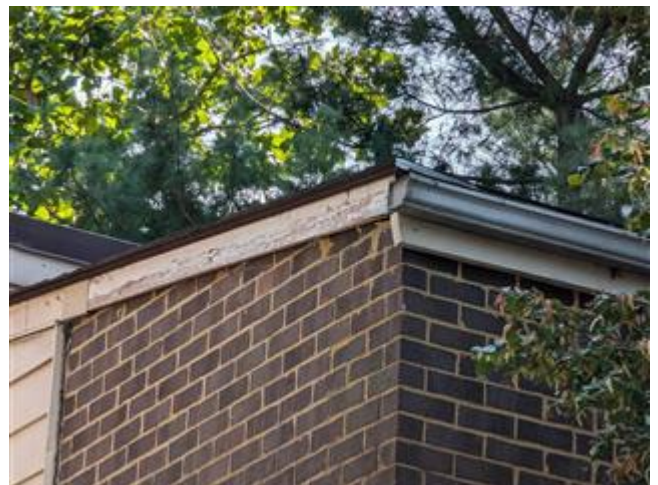
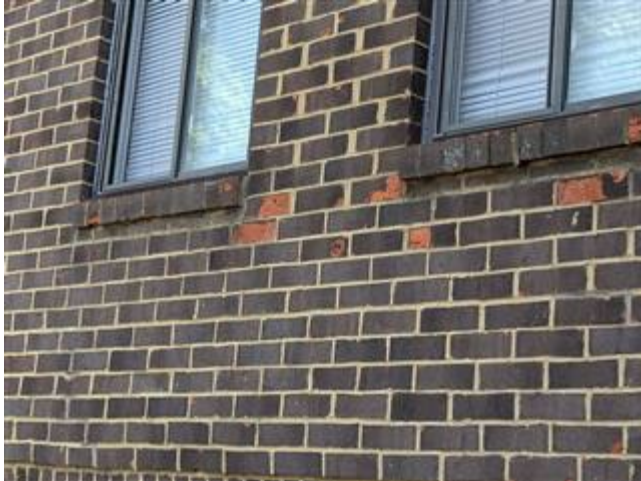
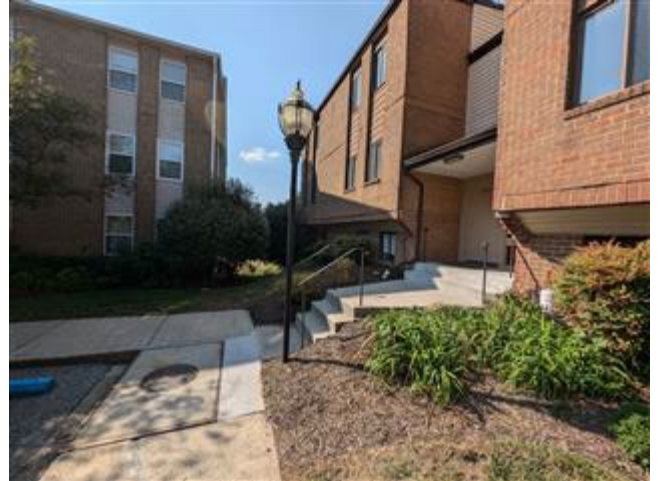
Siding and Trim. The buildings' exteriors are clad with a combination of brick, vinyl siding, and trim. The vinyl siding and trim materials appear to be in generally fair condition. There were noted problems with brick and vinyl siding.

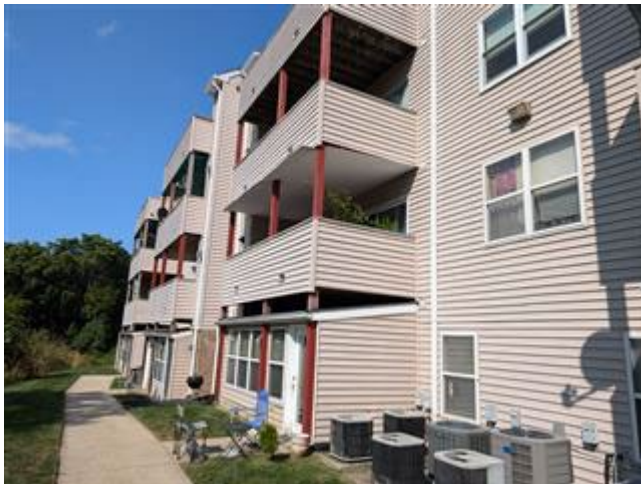
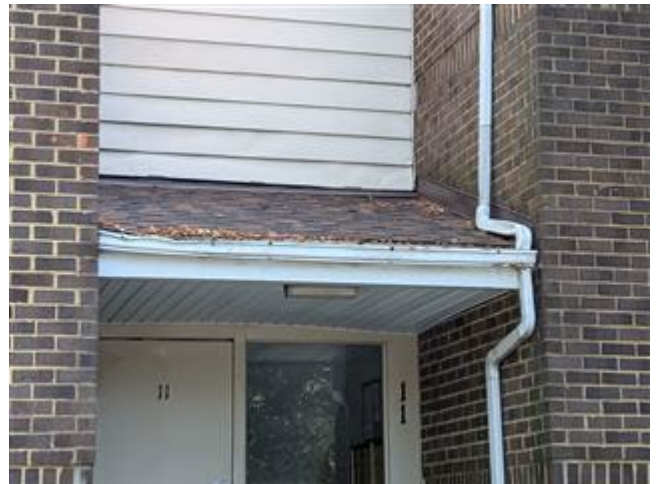
Brickstone masonry is used as the main exterior cladding of the building. There is significant damage at Steel lintels. This damage was identified in the study performed in 2010. There were no discernible repairs made to the damaged brick. As masonry weathers, the mortar joints will become damaged by water penetration. As additional water gains access to the joints, repeated freeze-thaw cycles gradually increase the damage to the mortar joints. If allowed to progress, even the masonry units such as brick, block, and stone can have their surfaces affected and masonry units can become loose.

Periodic repointing and local replacement of damaged masonry units will limit the damage done by moisture penetration. For this study, we assume that 10% of the masonry will require repointing every 10 years after approximately 30 years. For additional information about masonry and repointing, please view the relevant links at <http://mdareserves.com/resources/links/building-exterior>.

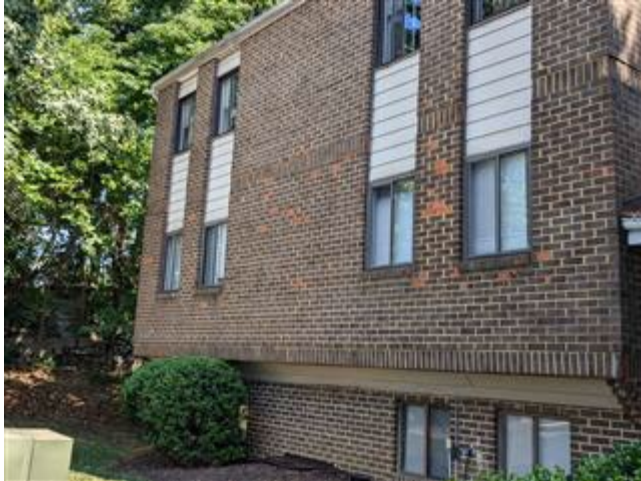
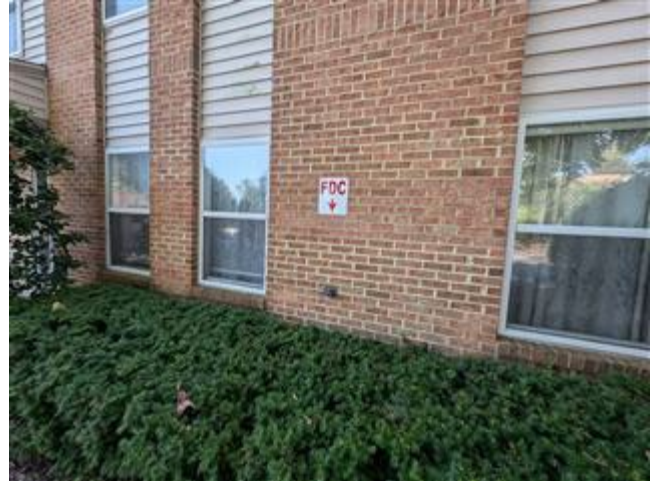
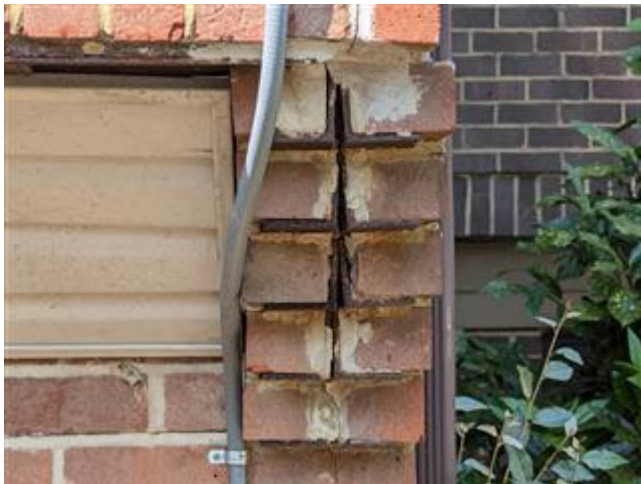
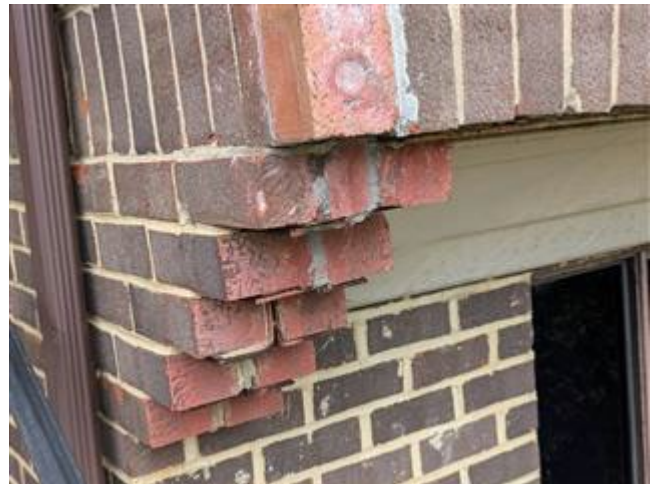
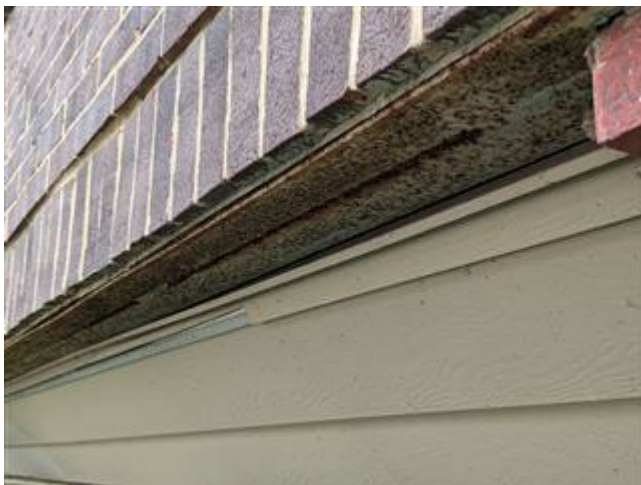
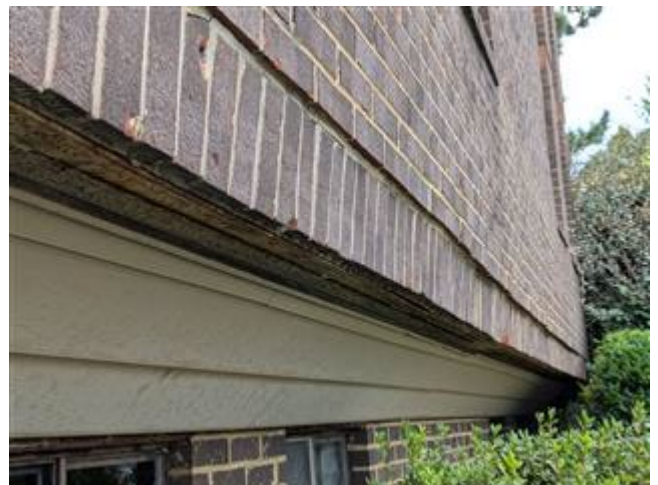
Steel Lintels. The steel lintels located on buildings' front brick facade are in poor condition. Defects include corrosion, sagging, and cracking of the brickwork above the lintel. Lintel repair, in conjunction with brick repairs, has been assumed in the funding analysis. The lintel repair cost has been estimated, cost for repairs can vary. The lintels should be assessed by a qualified exterior envelope firm. Adjustments to the analysis, if needed, can be made in future reserve analyses.

Corroded steel lintels will cause the brickwork to crack because of the expansion of the thickness in the steel. Corrected early, repairs can be made without having to remove the supported brickwork. If the damage is allowed to continue, it may become necessary to remove the entire supported brickwork. The first cracks typically appear at the corner of the window or door. As it progresses, it will stair step up the wall away from the opening. Depending on the severity of the corrosion, it may be necessary to replace the steel lintel.

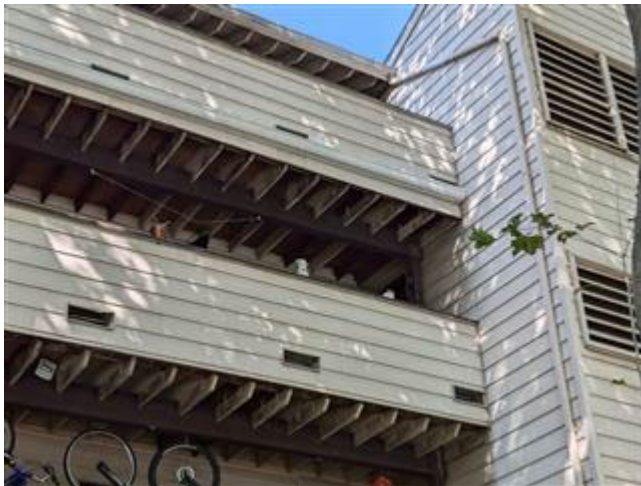
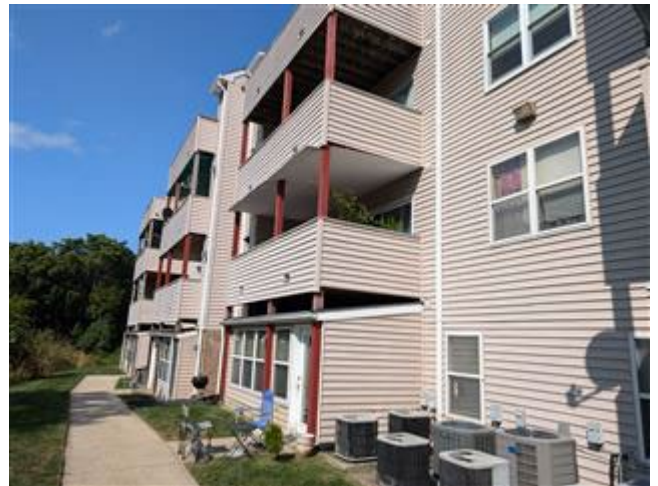
Please note that MillerDodson did not conduct a structural evaluation of the exterior stairs, decks, or balconies. Such an evaluation is beyond the Scope of this Reserve Study. MillerDodson strongly recommends that the Association retain the services of a Structural Engineer to conduct thorough and periodic evaluations of the buildings, balconies, and any other structural components of the buildings and amenities of the Association.

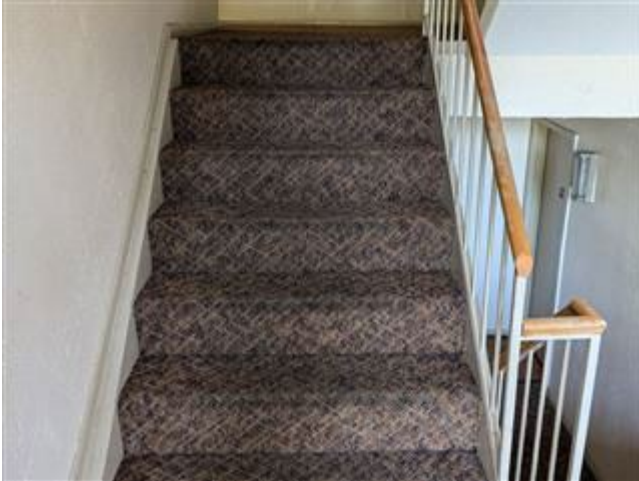
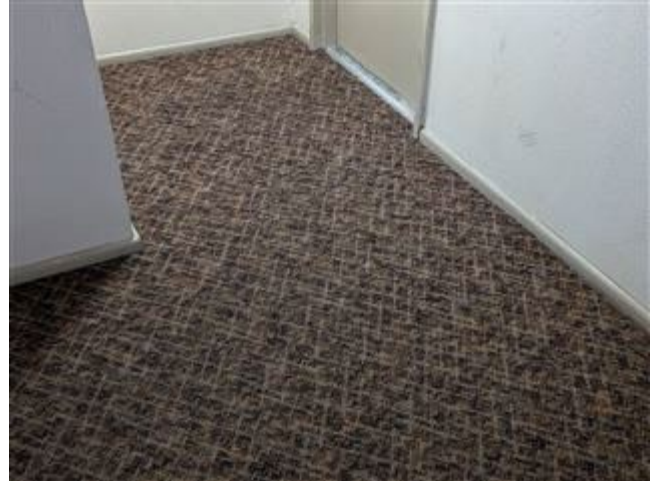
Stairwells. The buildings have an interior stairwell. We consider the stairs and the landings to be life of structure items and, therefore, are excluded from the Reserve Analysis. We have included the following items in the analysis carpet, floor tile, light fixtures, emergency lights, and exit lights. All components appear to be in good operating condition.

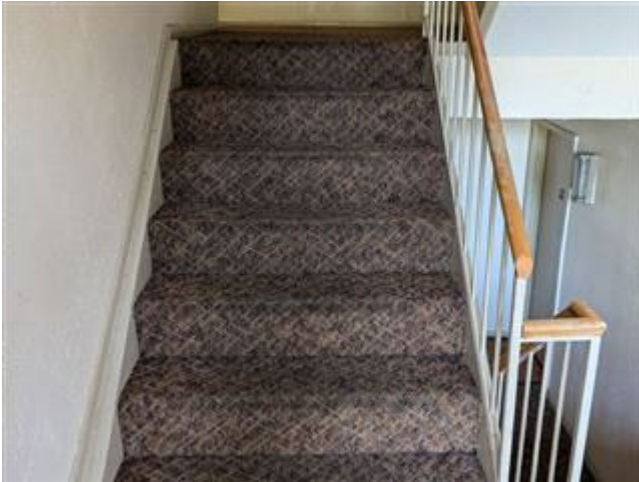
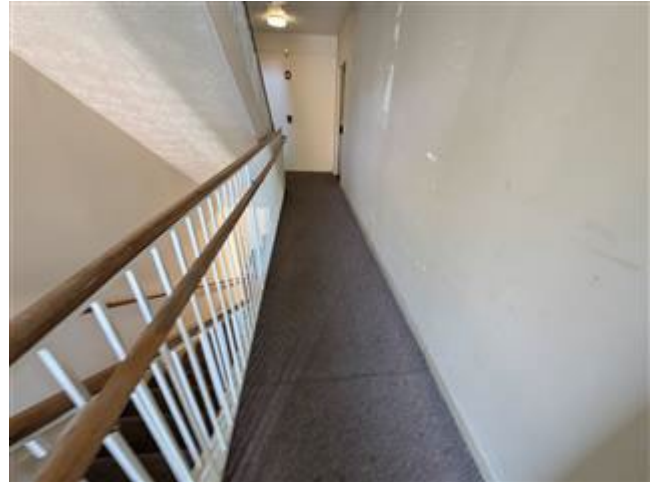
Lighting. Halls and common areas are illuminated by incandescent ceiling fixtures. The light is dated and appears to date from the original construction. In addition, each unit has a wall sconce at the unit entry doors. Funding for future replacement of the lighting has been programmed in the analysis.

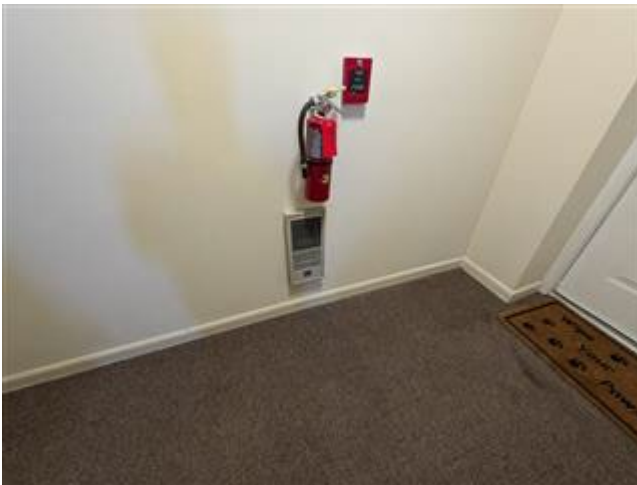
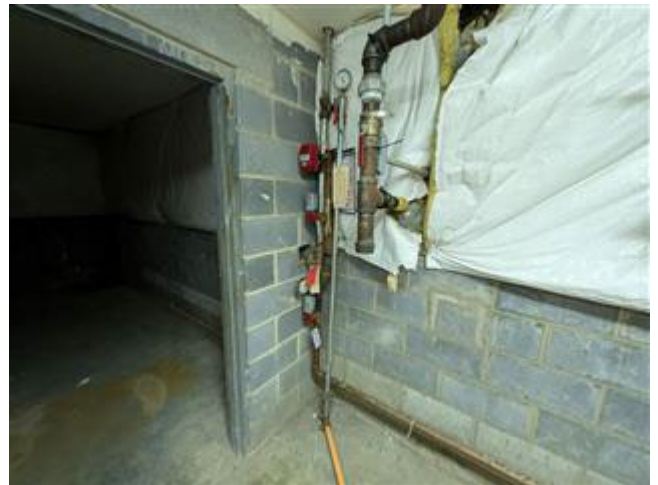
Building Piping. Copper water supply pipes have been used throughout the facility. During the site visit, it was noted that materials were being removed at one building. Testing for asbestos is beyond the scope of this study. The buildings are approximately 45 years old. As a result of changes in water chemistry, brought on by federal clean water legislation, piping has been developing pin-hole leaks, which can lead to higher maintenance costs and a shorter than normal service life.

To gain a better understanding of the condition of this facility's pipes and water supply lines, we recommend having an expert evaluation of the piping performed. This evaluation should provide an estimation of the remaining useful life of the piping systems, the condition of the water supply, and recommendations for a replacement to maximize the remaining useful life of this facility's piping systems.

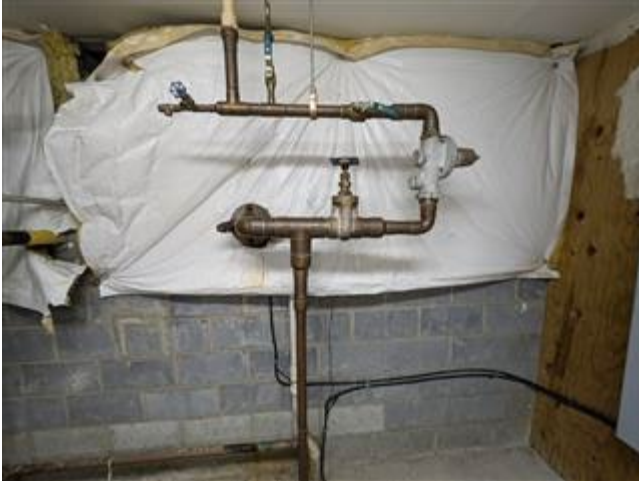
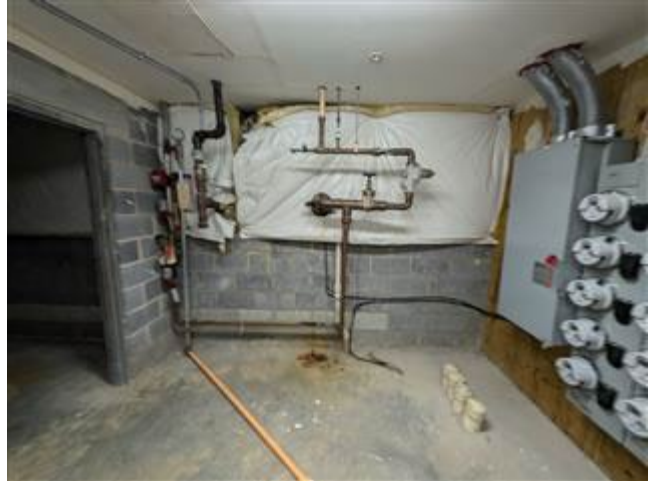
Water Heaters. The Association maintains thirty-five, gas-fired water heaters. Some buildings have two water heaters. The age of the water heaters ranges from 2 to 18 years. The average age of the water heaters is eight years. Funding for the replacement of one water heater every two years has been programmed in the analysis. In two buildings, which were rebuilt in late 1990's, hot water is supplied by individual unit water heaters owned by the unit owner. In another building, the hot water system has been converted to solar.

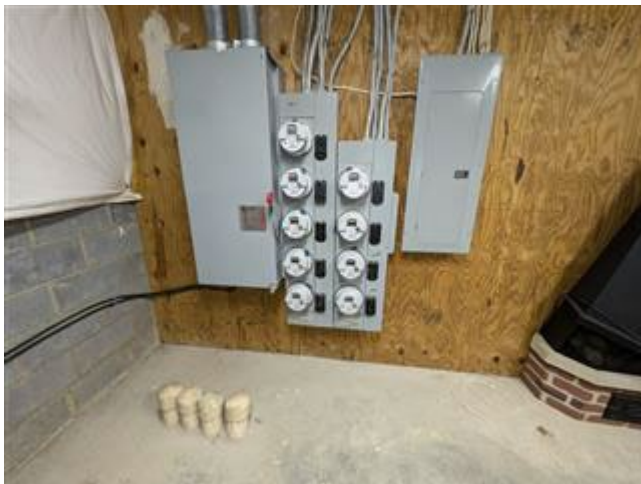
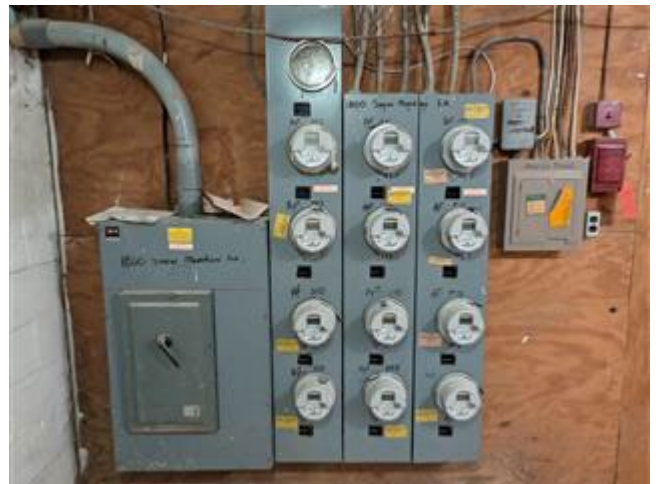
Electrical Switchgear. The electrical switchgear includes the facility's primary distribution equipment, disconnects, relays, fuses, and circuit breakers—the primary electrical switchgear dates to the original construction of the building. Electrical switchgear has a rated service life of 50 years or more. Electrical switchgear requires ongoing maintenance for proper operation and reliability.

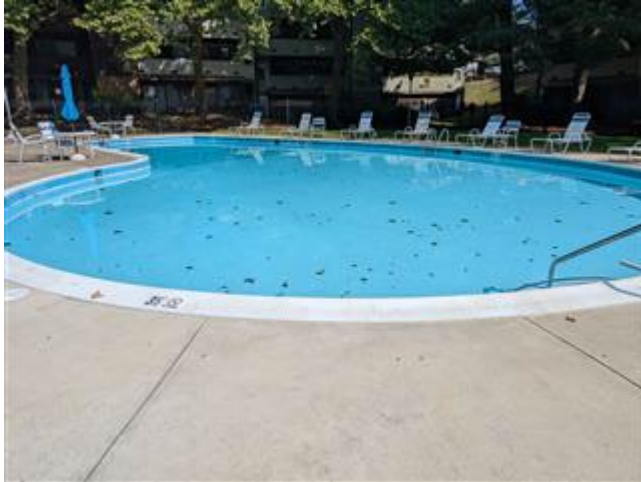
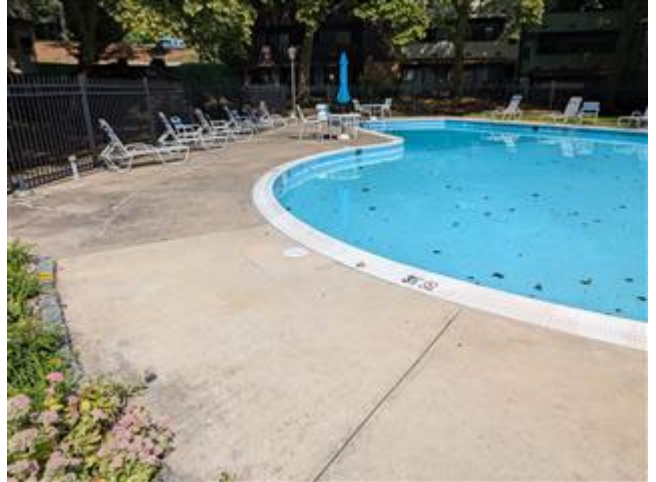
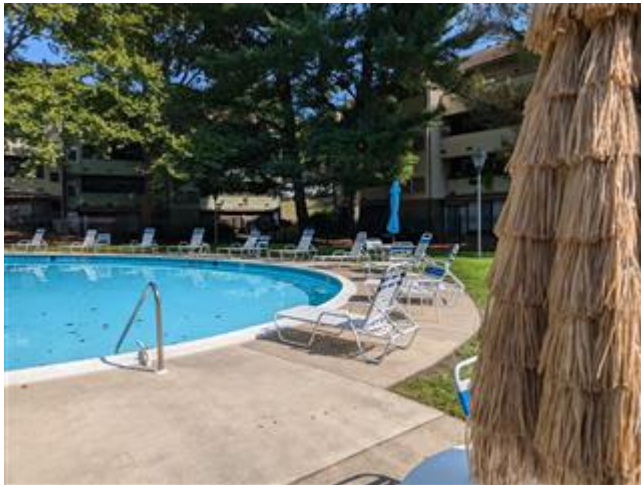
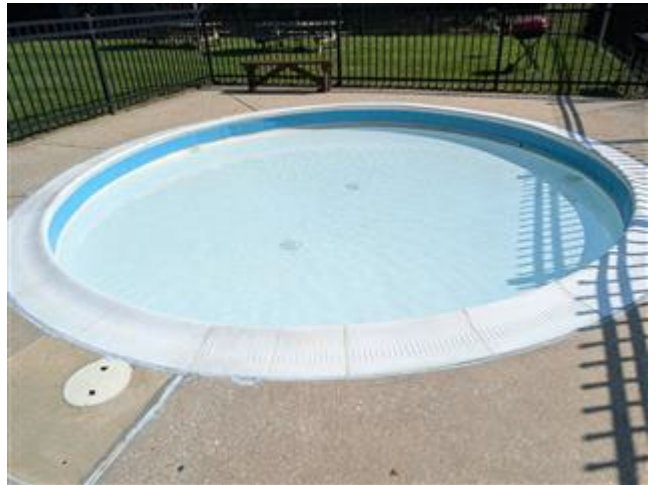
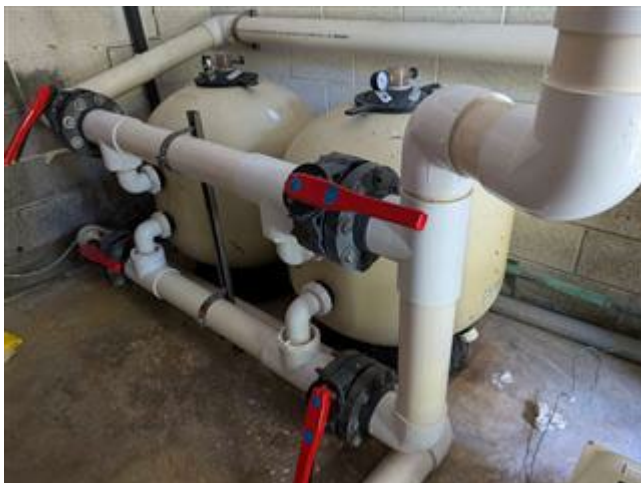
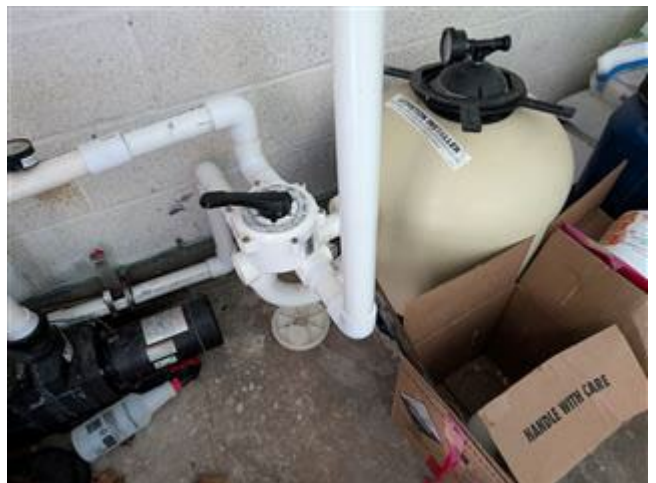
Pool House. The community maintains pool house which contains women's and men' shower rooms, and guard station. The shower rooms include commodes, urinal, sinks and showers. The overall condition of the shower rooms appears to be good. There is a wood board partition at shower rooms' entrances that is in poor condition.
